# Large Scale Outdoor Fire Demonstration Program

**July 17, 1998**

**Greenstone Industries  
(now U.S. GreenFiber)**

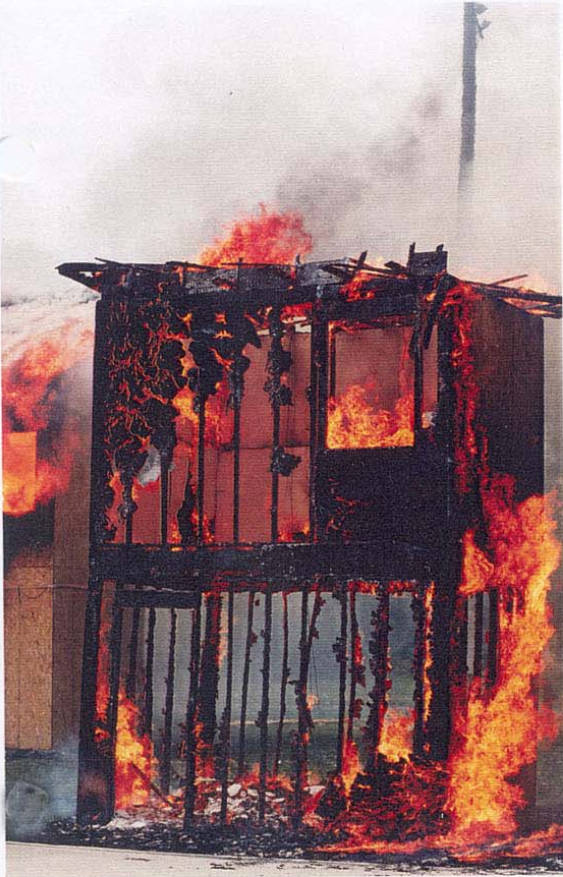
Structure with no insulation collapsed 40:10 after ignition.

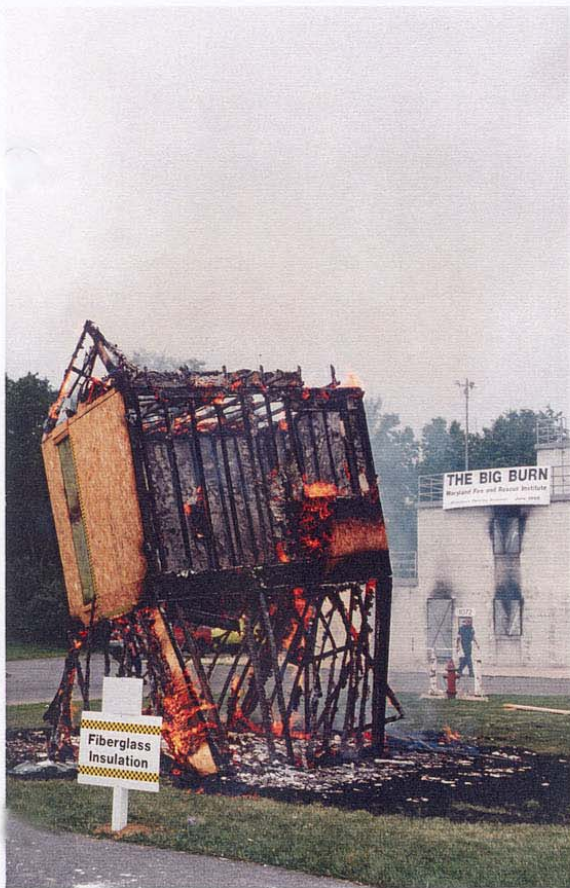
Structure with fiberglass insulation collapsed 42:26 after ignition.

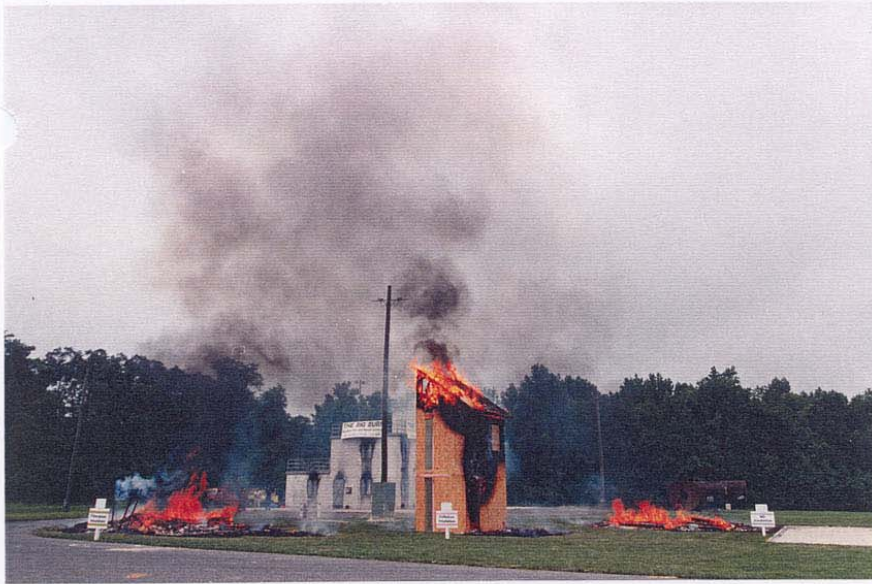
Structure with cellulose insulation resisted the fire 57% longer than the fiberglass structure.

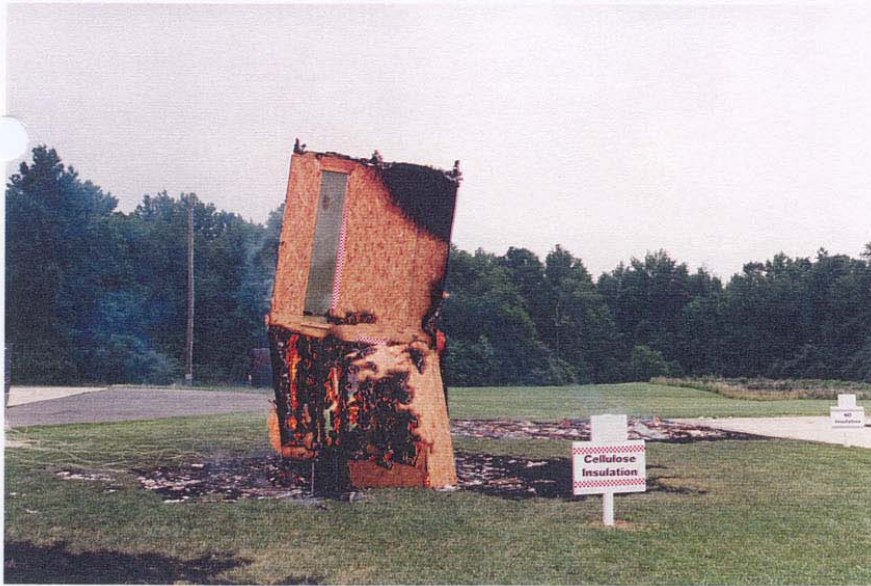
Structure with cellulose insulation collapsed  
66:45 after ignition.
